# Saguaro Mechanical Services

## Preventive Maintenance Report

Job **SMS-26-04817** · Work order PM-Q2  
Tue, June 16, 2026 · 11:05 AM – 1:22 PM MST

| CUSTOMER | SITE | EQUIPMENT | TECHNICIAN |
|---|---|---|---|
| <b>Cholla Street Kitchen</b><br>Attn: Dana Whitfield, GM<br>(602) 555-0187<br>dana@chollakitchen.example | <b>Desert Bloom Plaza #104</b><br>2150 E Ocotillo Plaza Dr<br>Phoenix, AZ 85016<br>Roof access via rear ladder | <b>RTU-2 · Dining room</b><br>Mesa Aire MA-RTU120G<br>S/N MA2219K08734<br>10-ton gas/elec · R-410A<br>460V/3Ø · installed 2019 | <b>Marco Delgado</b><br>Senior Service Tech · #T-07<br>EPA 608 Universal<br>Agreement: Quarterly PM |

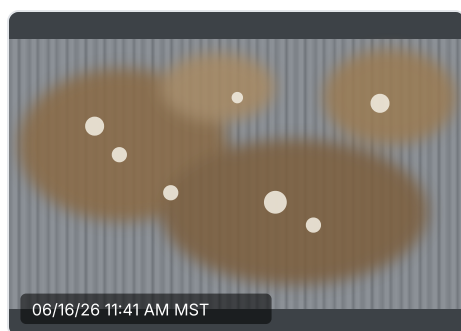
Condenser coil – before

| Item | Result | Technician comment |
|---|---|---|
| Condenser coil | FIXED | Cottonwood/dust matting on ~40% of face. Cleaned with coil cleaner, rinsed. |

Condenser coil matted with cottonwood and dust, likely from the plaza's landscaping. Filters well past due. Belt slipping on start-up.

Cottonwood and dust matting, ~40% of face

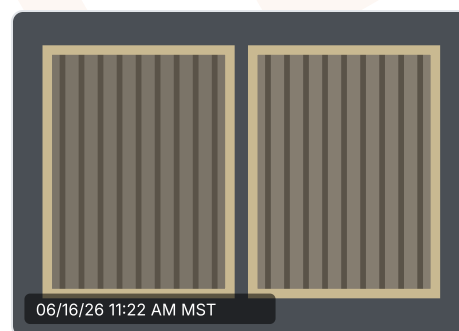
Return air filters – before

| Item | Result | Technician comment |
|---|---|---|
| Air filters | FIXED | 4 × 20×25×2 MERV 8 heavily loaded; replaced. |

Heavily loaded, restricting airflow

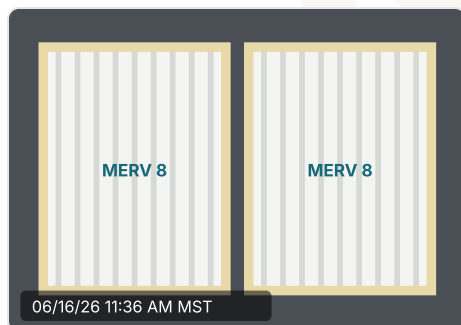
Return air filters – after

4 x 20x25x2 MERV 8 installed

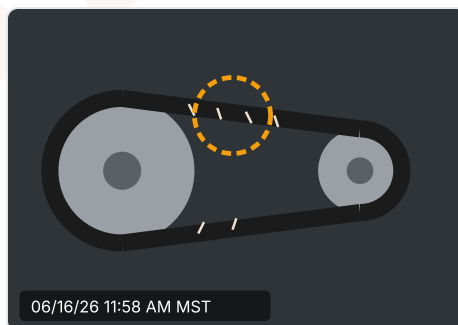
Blower belt – before

| Item | Result | Technician comment |
|---|---|---|
| Blower belt & pulleys | FIXED | Belt glazed with edge cracking; replaced (A42) and tensioned. Pulleys aligned. |

Glazed, edge cracks; replaced with A42

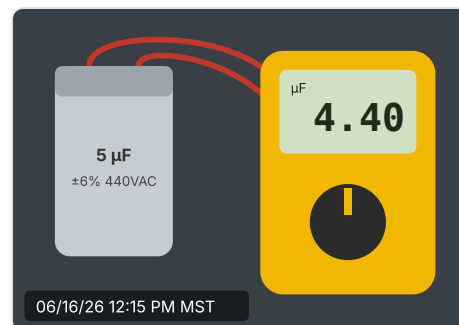
CFM-2 run capacitor test

| Item | Result | Technician comment |
|---|---|---|
| Run capacitors | ATTN | CFM-2 capacitor 4.4 μF vs 5.0 μF rated (–12%). See recommendation #1. |

| Measurement | Reading | Reference / target | Status | Note |
|---|---|---|---|---|
| CFM-2 run capacitor (rated / measured) | <b>5.0 / 4.4 μF</b> | ±6% → 4.7–5.3 | LOW | –12%, replace |

Measured 4.4  $\mu\text{F}$  against a 5.0  $\mu\text{F}$  rating (12% low). A weak capacitor makes the fan motor run hot and can lead to motor failure and high head pressure on 110°F+ days.

4.40  $\mu\text{F}$  measured vs 5.0  $\mu\text{F}$  rated

### 1. Replace condenser fan motor #2 run capacitor

Within 7 days
